**الموضوع :** نسخة عن تقرير شركة الاتحاد الهندسي ش.م.ل (خطيب وعلمي) حول  
وضعية أهراءات الحبوب في مرفأ بيروت.

Ref: BY0000/L005/22

الموضوع: إستقرار أهراءات الحبوب في مرفأ بيروت

**BEIRUT PORT  
GRAIN SILOS  
STATUS  
ASSESSMENT**

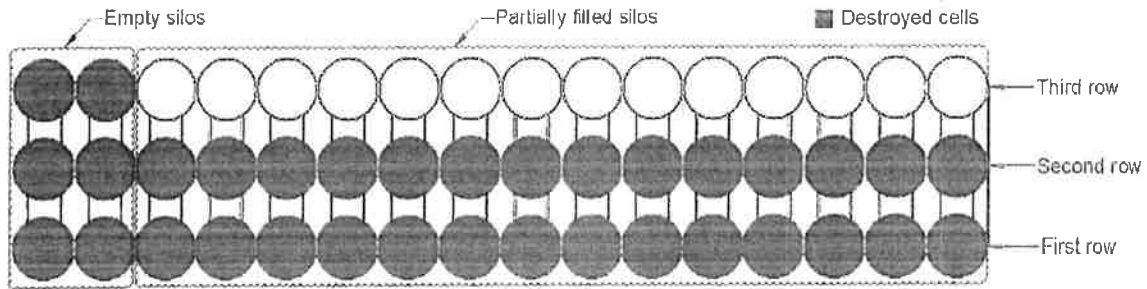
A significant damage occurred to the grain silos as a result of the explosion. The damage is concentrated at the Eastern part of the Silos and has mainly affected the first and second rows as shown in the series of figures below.

Figure 2. Sketch Showing Damaged Silos (Source: Paper - Beirut Explosion - Structural Assessment of the Explosion Magnitude)

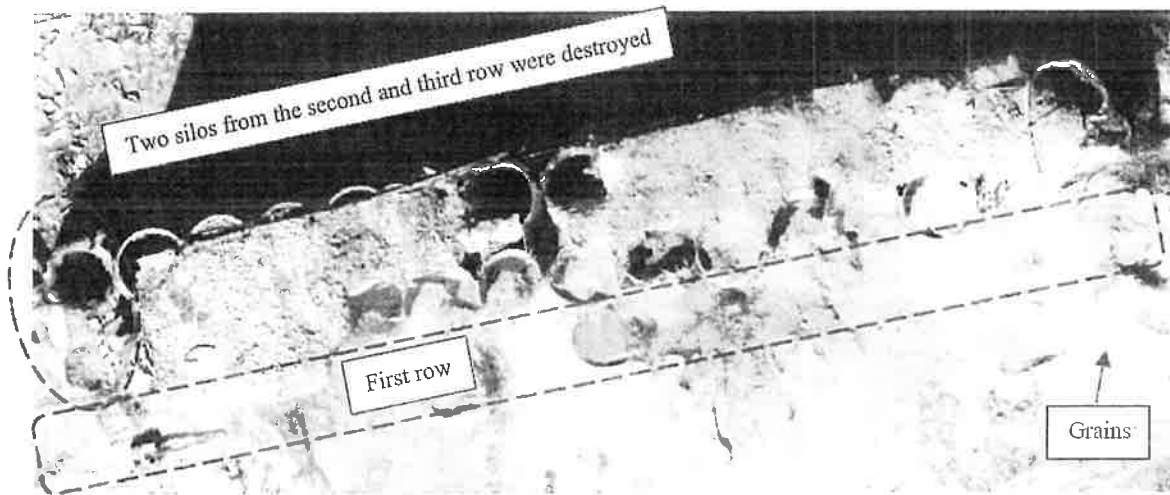
Figure 3. Aerial Photograph Showing the Damage by the Lebanese Air Force (Source: Paper - Beirut Explosion - Structural Assessment of the Explosion Magnitude)

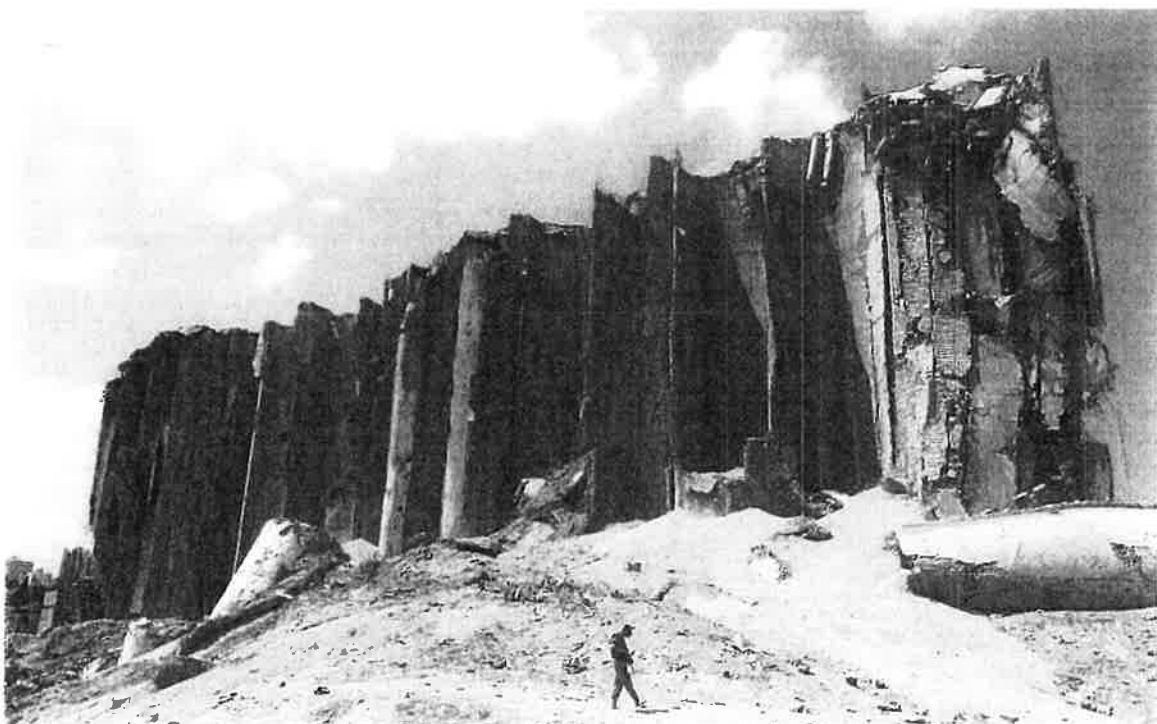
Figure 4. A Front View (Looking to the West) Showing the Damaged Silos

In addition to the collapse of parts of the silos, some concrete slabs and vertical elements / walls remain loosely hanging by reinforcing bars to the remaining elements and they are prone to collapse anytime which necessitates the implementation of a safe buffer zone to protect people in the area against potential unfortunate accidents. This safe buffer zone has already been recommended by KA experts.

- A. Removal of all loose hanging concrete slabs, walls and debris.
- B. Extensive remote-sensing investigation, geophysical and geotechnical surveys, and testing of the foundations condition including laboratory testing on concrete and steel.
- C. Possible reinforcement of the structure and its existing foundations through measures which will be defined later based on the outcome of the detailed analysis.
- D. Installation of continuous displacement monitoring system.

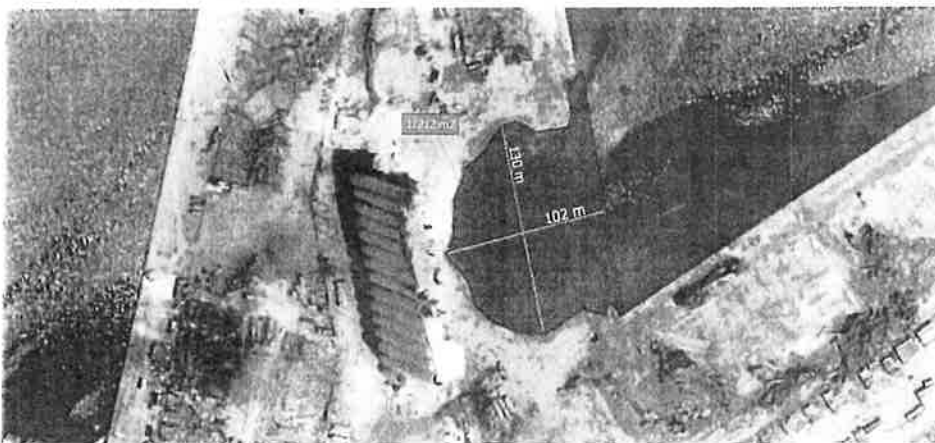
Regarding the foundations of the silos, the extent of damage at this time can only be inferred from engineering calculations and from the observed movement of the northern silos block. It is expected that many of the precast piles have failed in shear and lost connection with the foundation raft. In addition, a large crater was created next to the silos which has probably affected/weakened the underlying soil conditions.

Figure 6: Large Crater Generated due to the Explosion next to the Silos

Confirmation of the foundations damage would require extensive instrumented inspections and investigations.

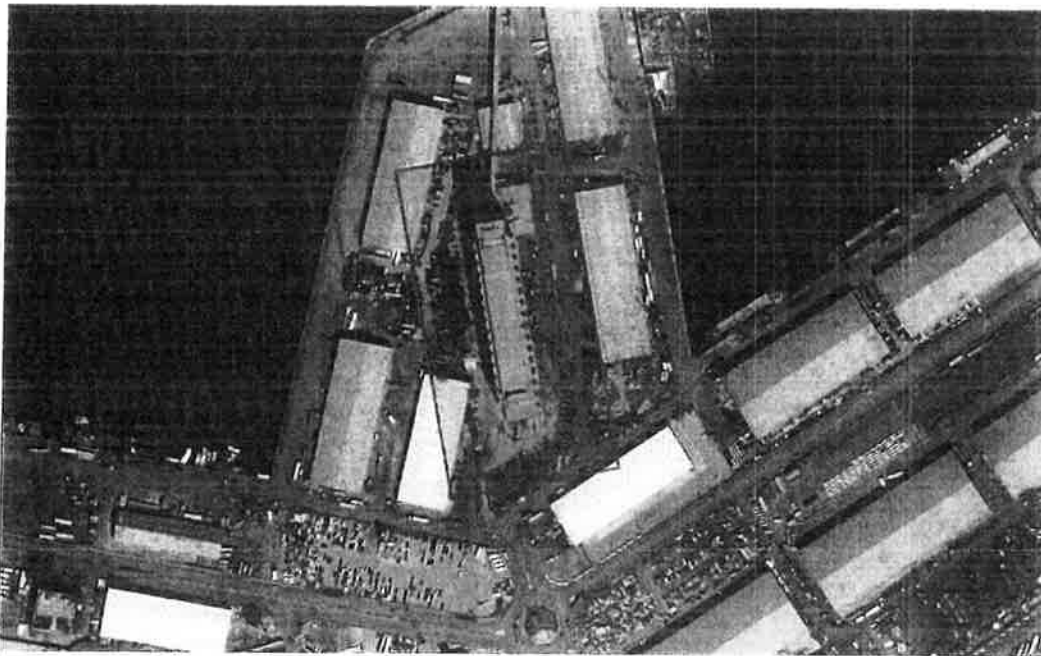
*Figure 7 50m Buffer Around Silos*

The silos can be considered dangerous to approach. A safety distance of some 50m should be maintained around the silos footprint should a decision be made to keep the silos in place.
