**الموضوع :** نسخة عن تقرير شركة الاتحاد الهندسي ش.م.ل (خطيب وعلمي) حول  
وضعية أهراءات الحبوب في مرفأ بيروت.

Ref: BY0000/L005/22

الموضوع: إستقرار أهراءات الحبوب في مرفأ بيروت

**BEIRUT PORT  
GRAIN SILOS  
STATUS  
ASSESSMENT**

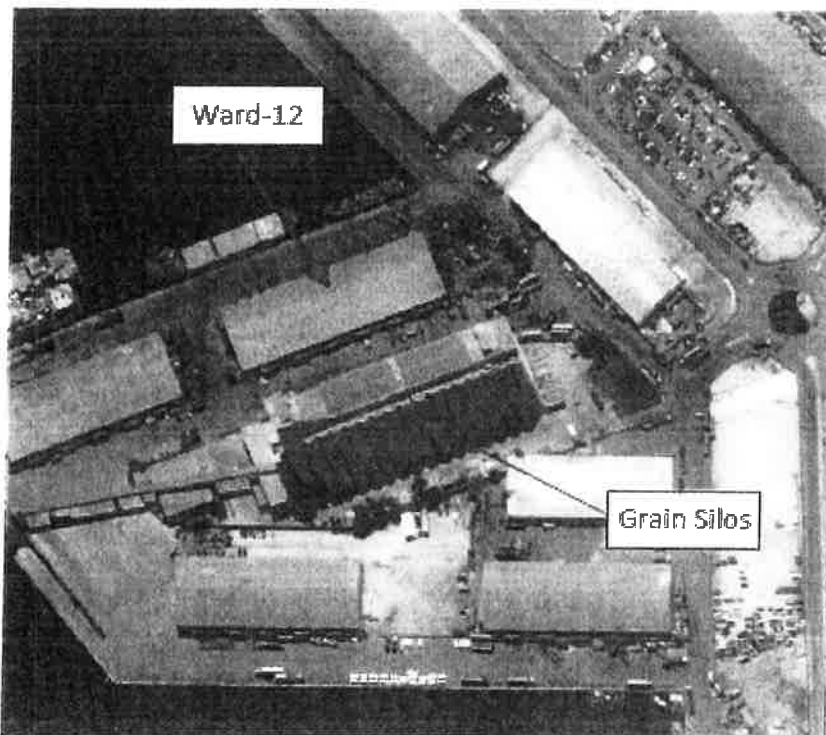
The deadly explosion in Beirut port significantly damaged the Beirut port silos which are adjacent to the center of the explosion, at around 85m proximity.

*Figure 1 Grain Silos Location in Beirut Port Before Explosion (Source: Pagar Beirut Explosion - Structural Assessment of the Blast Site, Page 104)*
